THE NEWS PUBLICATION FOR MEMBERS

OF THE 1937-1938 BUICK CLUB • FOUNDED 1980

Volume V • Number 8

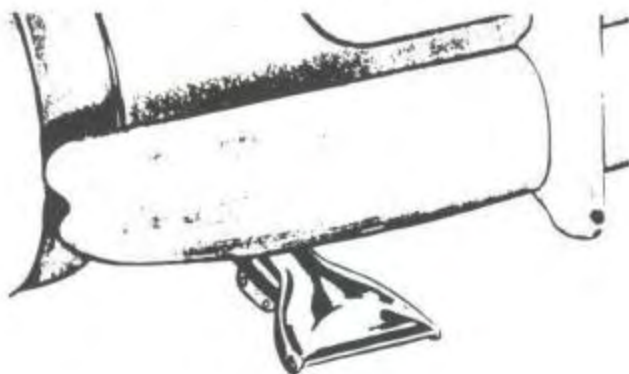
BUICK EXHAUST PIPE TRIM

Part No. 982088

Steel stamping, heavy nickel chrome plate.
Baffled, so that hot exhaust gases do not strike the top surface.
1 3/8 inch pipe diameter, will fit pipes from 1 1/2 to 2 inch O.D.
Packed singly in attractive carton.
Self clamping flanges with two 1/4 inch bolts.

Dresses up the exhaust pipe which otherwise is generally rusty and objectionable looking.
Keeps exhaust gas down and away from the rear bumper.
Retains its brightness because the top section does not become overheated.

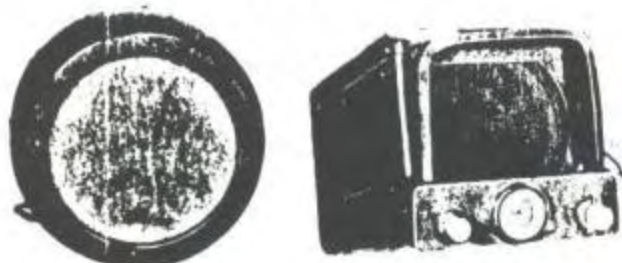
BUICK CENTERLINE DUAL RADIO Part No. 980567

6 tubes, 5 Octal base and 1 all metal in circuits as follows:

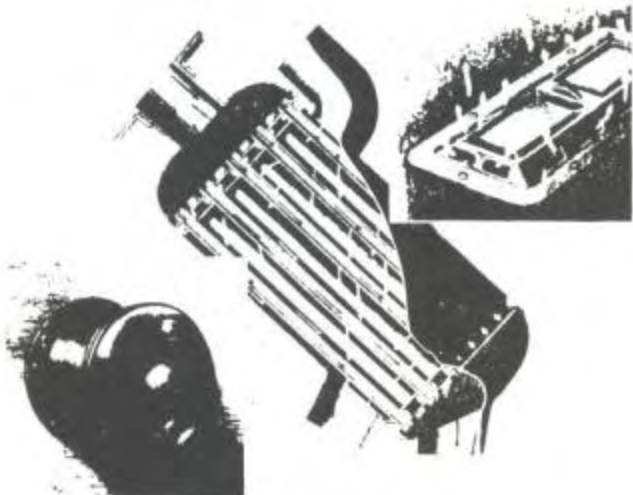
BUICK HOT AIR HEATERS

Welded steel unit in exhaust line under hood.

Leak proof front and rear registers.

NOTE: Not equipped with windshield defroster outlets. For defrosting purposes in Hot Air Heater equipped cars, fan type defroster fan is recommended.

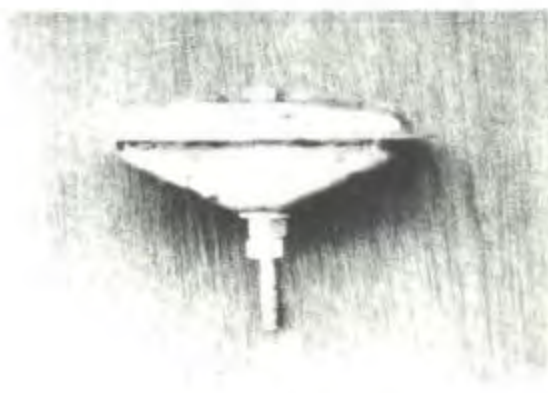
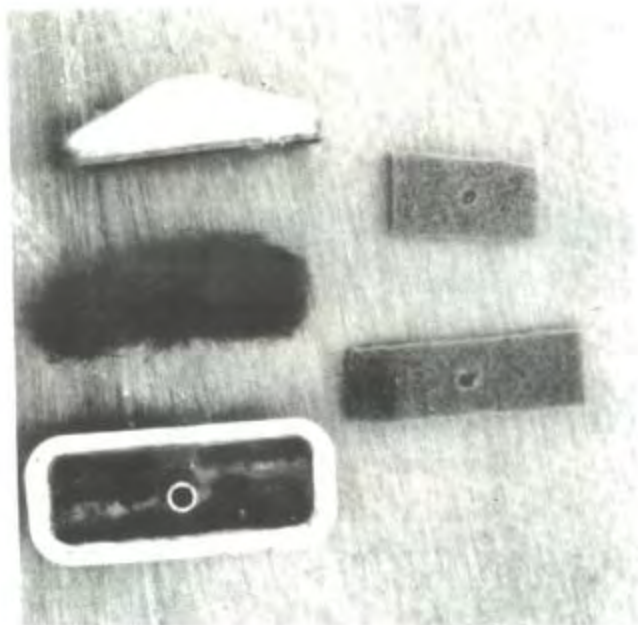
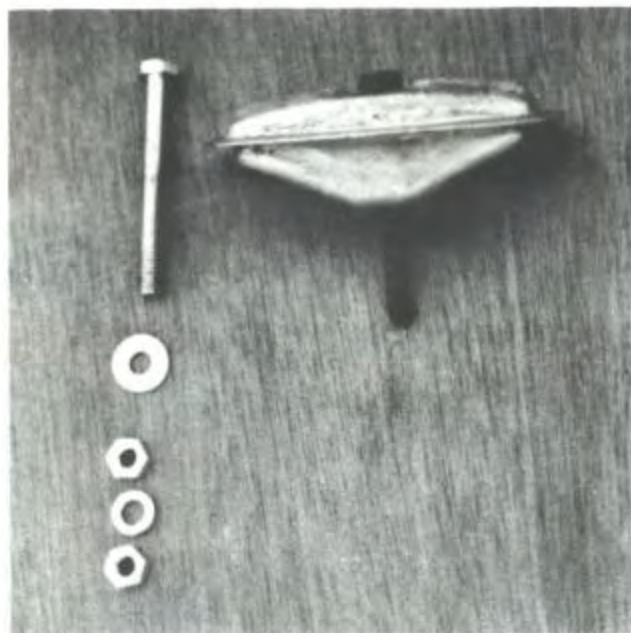
The breather housing has two pieces: front and back. These two pieces are held together by a ferrule which is flanged on each end. A bolt passes through the ferrule to attach the breather unit to the crankcase. This bolt must be replaced by a bolt of the same size and length, but the new bolt must have threads at least half the length of the bolt. (The one I used was fully threaded.) You'll also need two nuts, and a flat washer. A lock washer to go between the two nuts is optional. These items should cost less than one dollar at a hardware store. While at the hardware store go to the sandpaper department and get a packet of 3-M stripping pads. They cost about \$1.50 and come in green or red. Take your pick. These are your new filters.

To make the modification, the ferrule flange on the back side of the unit must be removed. Carefully grind or file the flange off. Once the flange is removed the breather unit easily separates. With the breather unit apart you can remove and dispose of the old hog hair type bottom of the breather housing, then cut a longer piece to fit over the first piece. Put holes in the centers of the filter material to allow the bolt and ferrule to pass through. I suggest you dip the filter material in light oil, shaking off the excess. Dirt in the air passing through this filter will tend to cling to the oil. Now re-assemble the breather housing with the new filters and pass the new bolt through the unit. Place the flat washer over the bolt and turn on a nut until it just snugs the flat washer against the back of the housing. Now tighten the second nut against the first nut. (A lock washer between these nuts is optional.) With these nuts tightened properly the housing pieces are held firmly together - yet the bolt will still turn freely, enabling it to be threaded into the engine block. When mounted to the engine block this improved breather unit shows no outward signs of modification.

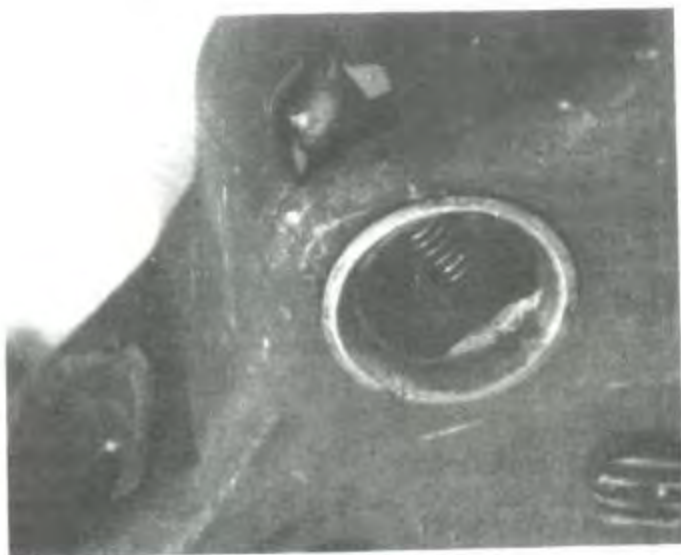
Tapered screw in brass latch bushing.

When installing the handle, you may need to seat it with an up and down wiggling action. Remember that the screw is only 8/32 in size (.164 over the thread diameter) and is threaded into a brass, not steel, bushing. Caution should be exercised here along with periodic inspection and tightening in the miles ahead.

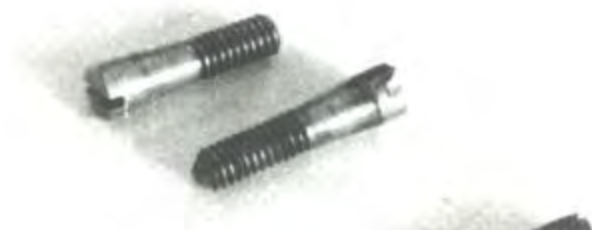
Reproduction and original screws.

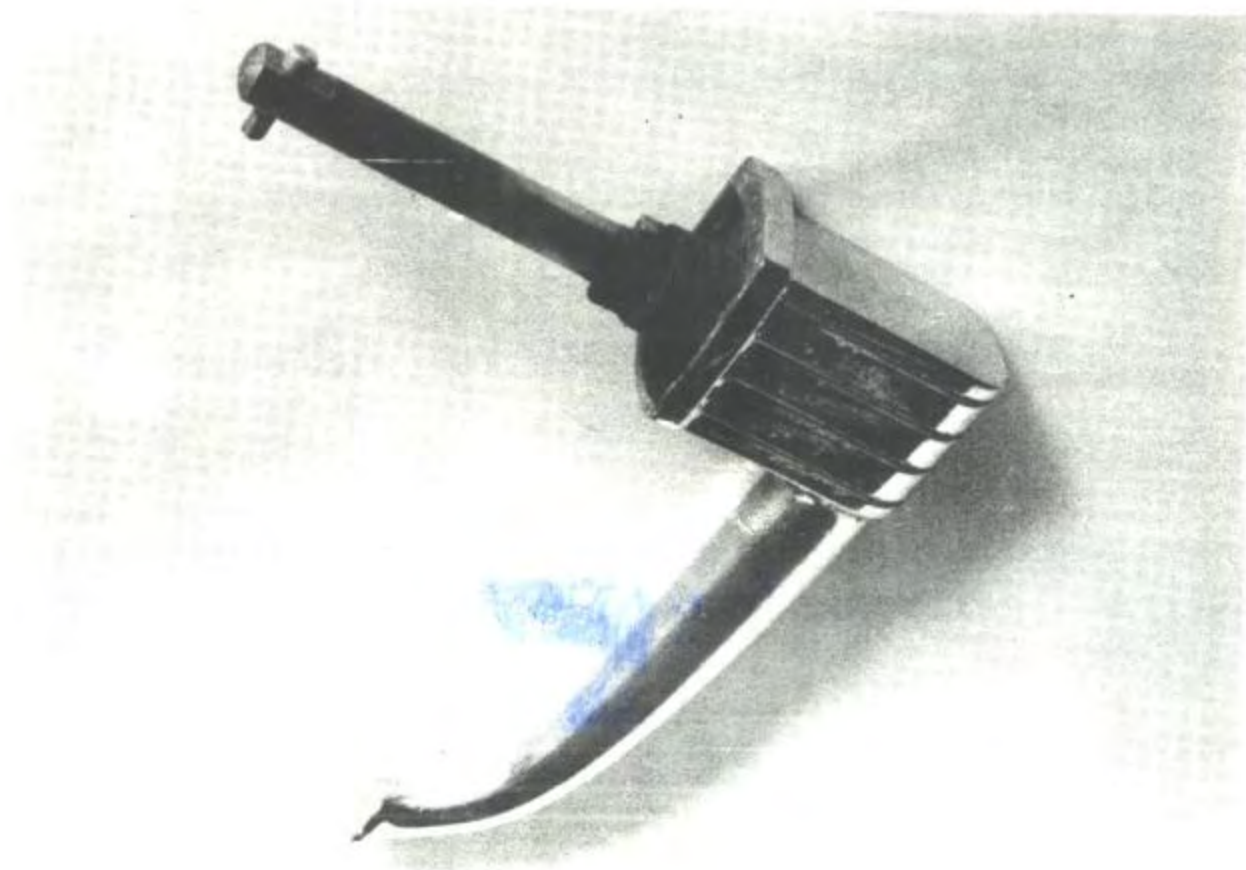
If your problems are more severe then it is the conventional approach; remove hardware, door panel, then lock mechanism. After cleaning, adjusting, shimming and lubrication, it's ready for installation. These photos will help you visualize and prepare for this project - its results being a like-new door operation.
